ISSUE STATEMENT

North Hudson Public Works Committee

Watermain connection at 719 Sixth St. N.

VILLAGE OF NORTH HUDSON
S.T.H. 35 WATERMAIN CONNECTIONS

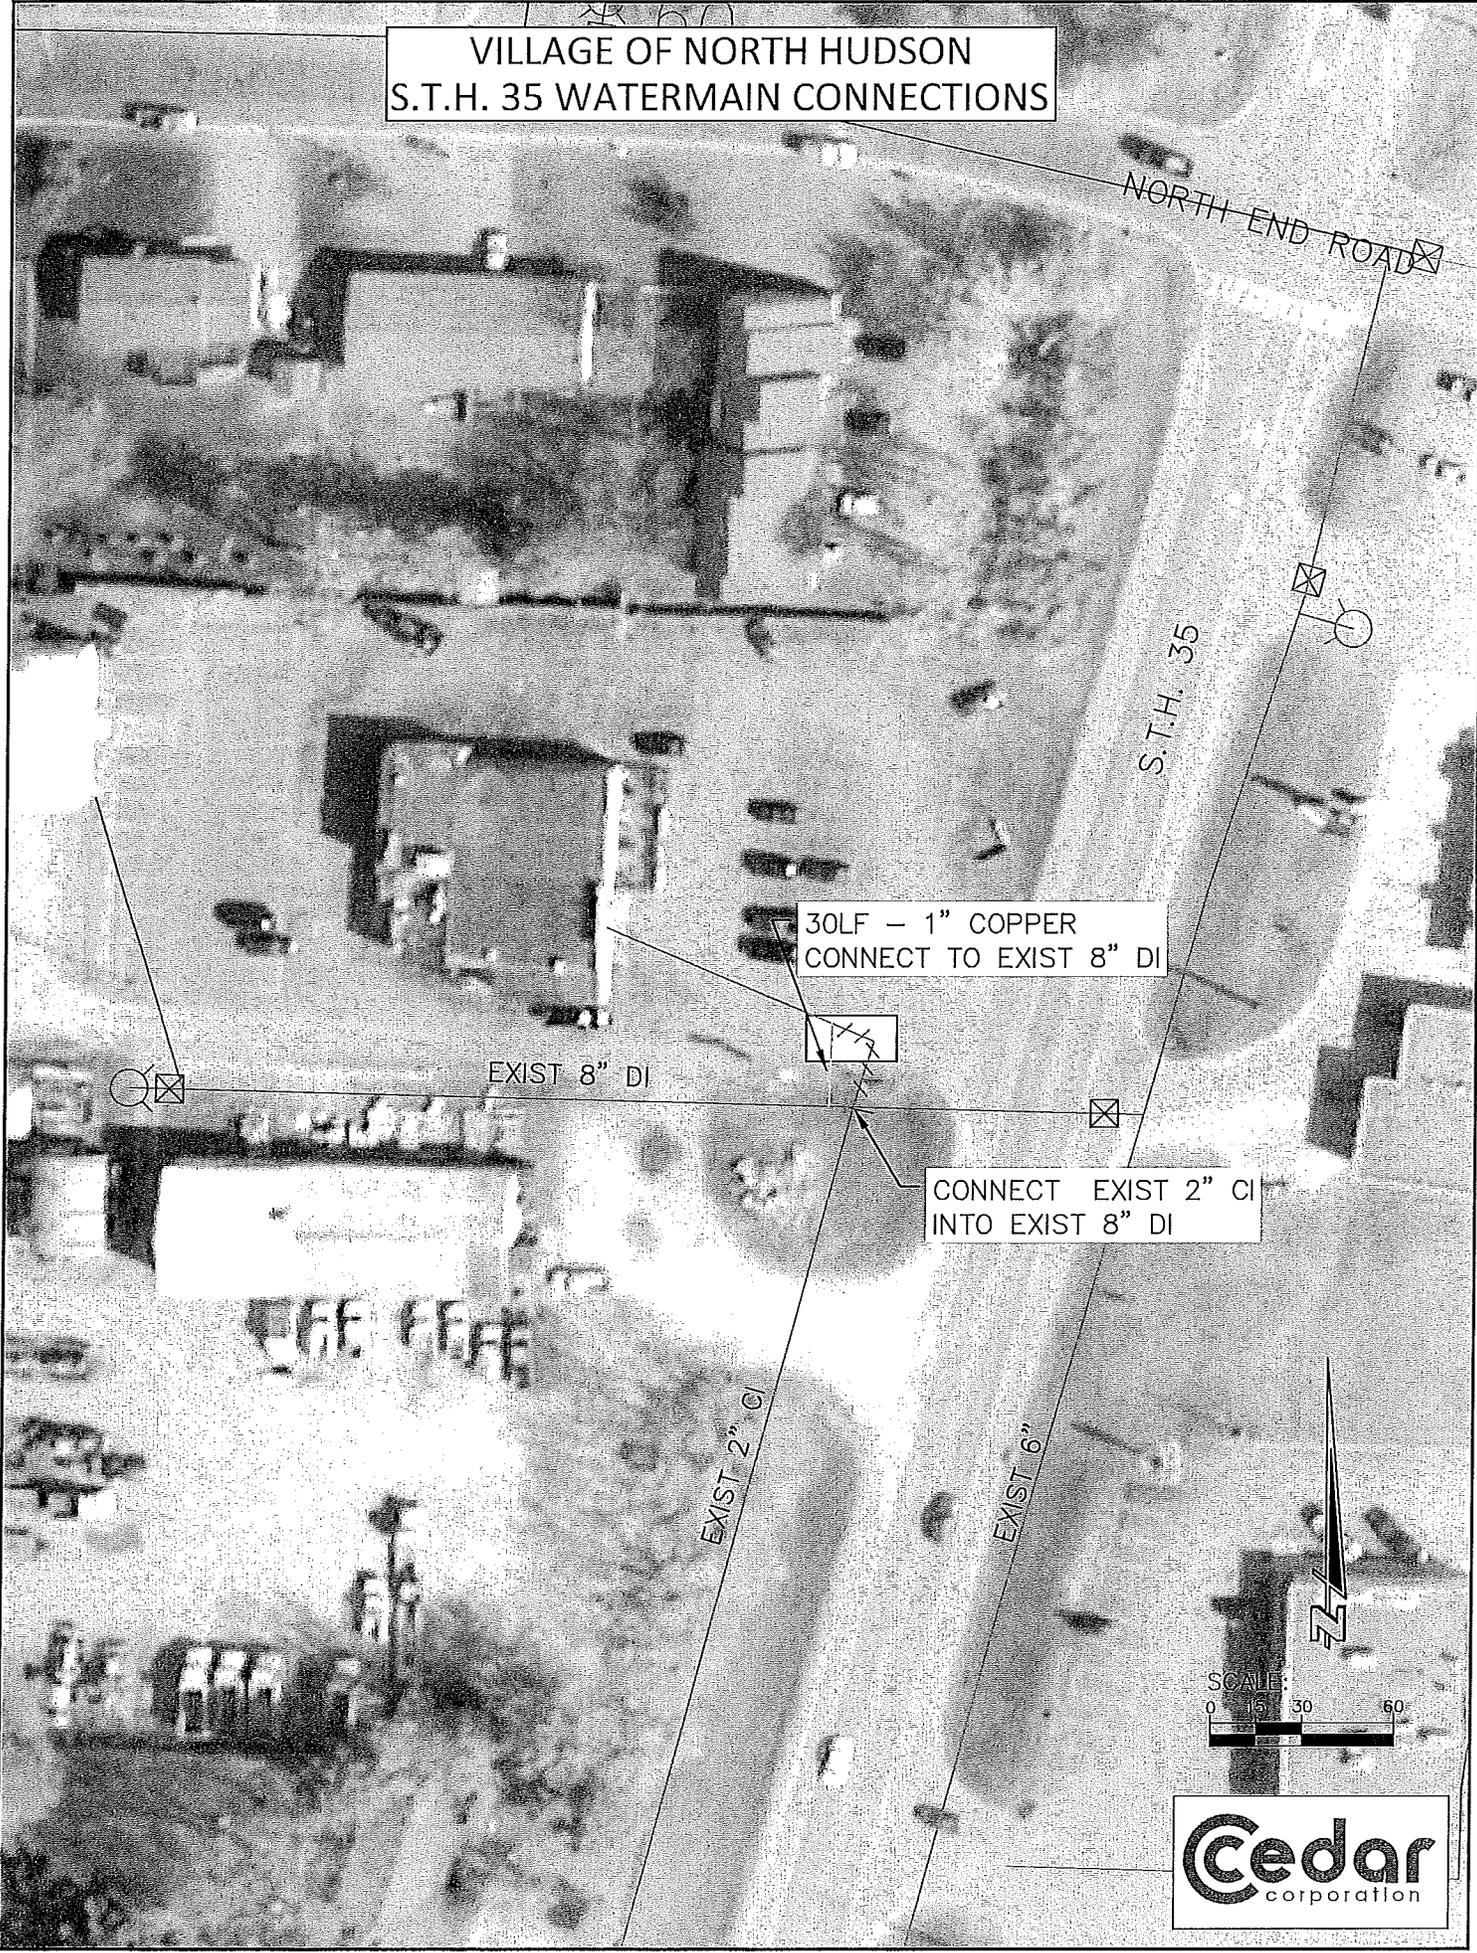
30LF - 1" COPPER
CONNECT TO EXIST 8" DI

CONNECT EXIST 2" CI
INTO EXIST 8" DI

- The existing 2 inch watermain is to be connected to the existing 8 inch watermain.
- Locate the existing 1 inch water service for the Village Inn at the existing curb stop and run new copper with new curb stop and stand and connect to the existing 8 inch main.
- Abandon remaining 2 inch main running north of the 8 inch watermain in place.
- Restore the disturbed area of the parking lot with gravel base and new asphalt.
- Restore the ditch with black dirt.
