I am writing in regards to a series of 3 walls constructed by the village in 1990 as part of the "Riverside Drive Improvement Project".

All 3 walls in the vicinity of 1004 Riverside Dr N are in various stages of failure and pose safety risk to pedestrians, vehicles and property.

**Riverside Drive - Retaining Wall Replacements
Village of North Hudson, WI**

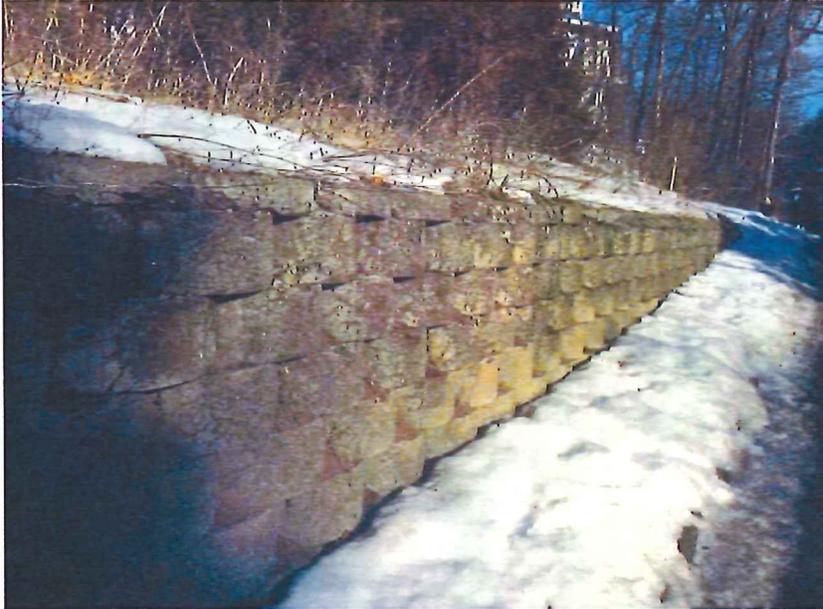
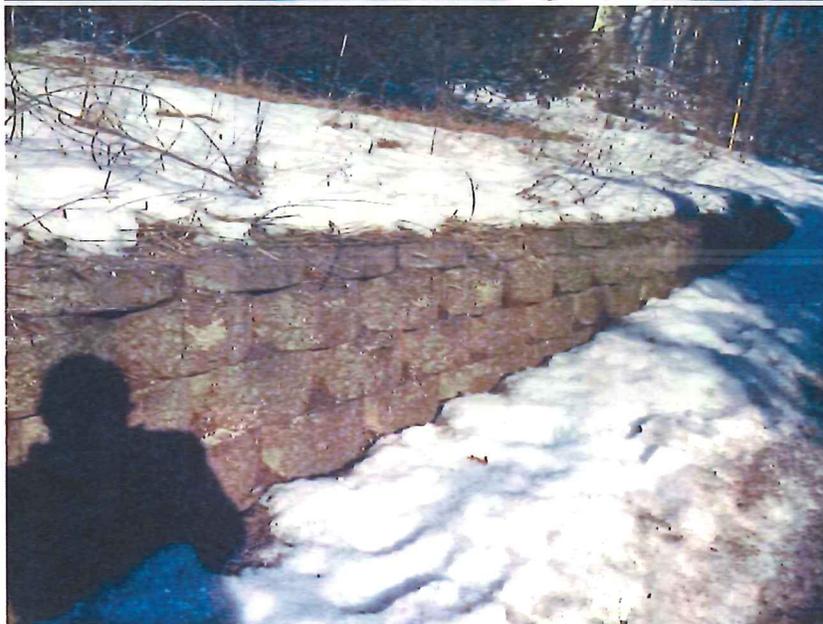
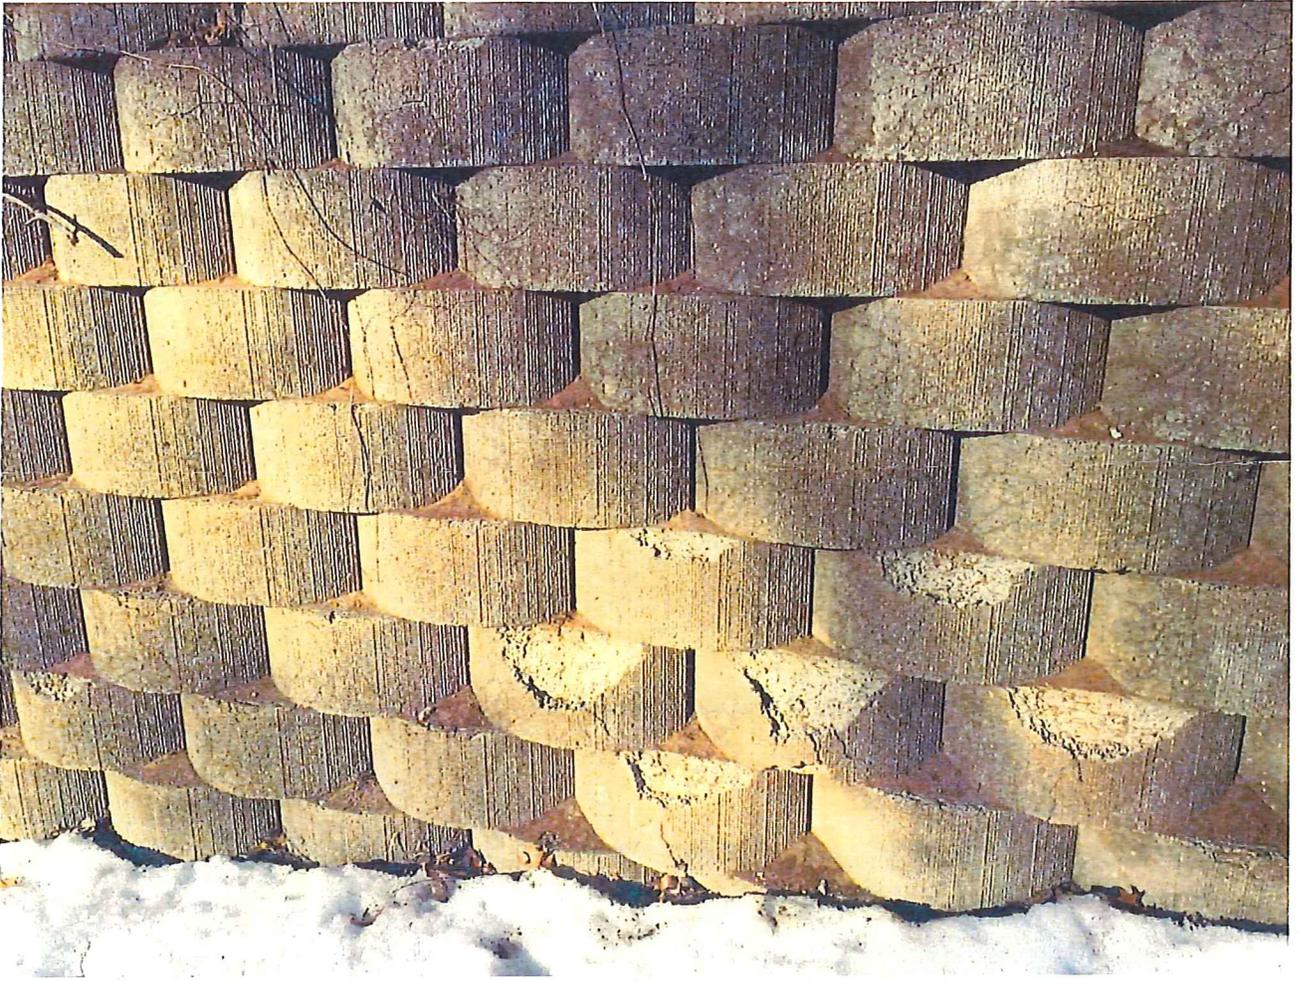
1. Wall 1 on north side of Riverside Dr N

- a. Numerous signs of deterioration
 - i. 3 degrees of lean downward
 - ii. Crumbling (scaling), wash-through, open joints, and deterioration of blocks at multiple levels. Most capstones are fully deteriorated.

There is a high potential for collapse onto Riverside drive causing damage to cars and injury to pedestrians.

All 3 walls were built to replace existing walls as a single Public Works project and need to be replaced as single engineered project. Wall 3 cannot be repaired, as an independent project, because it will require re-grading of the driveway which will potentially undermine Wall 2. Additionally it will need to be excavated in the near future for the replacement of Wall 2.

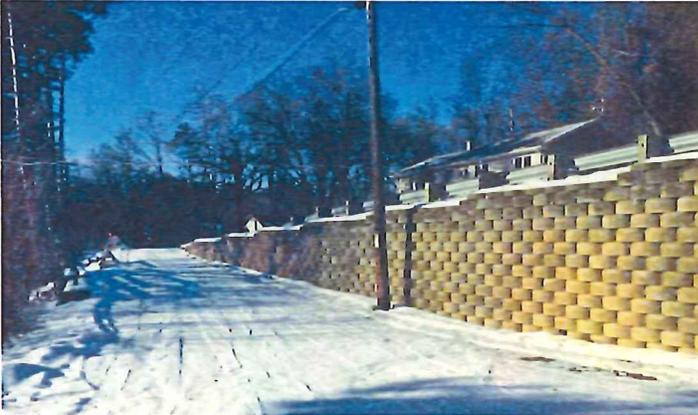
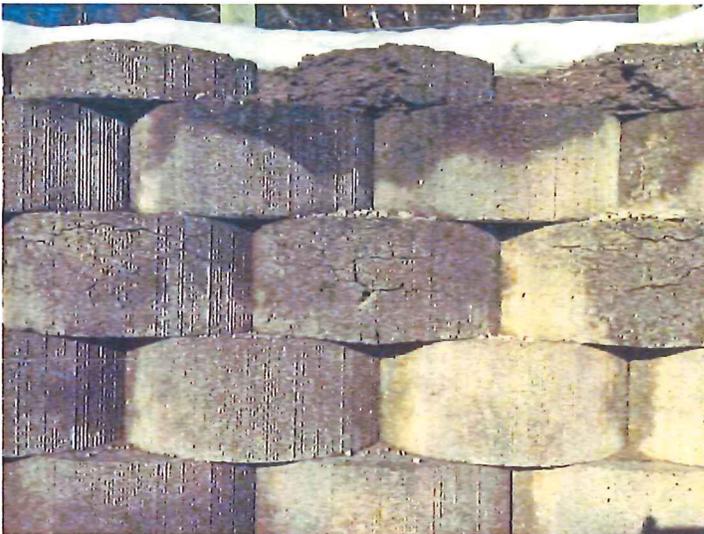
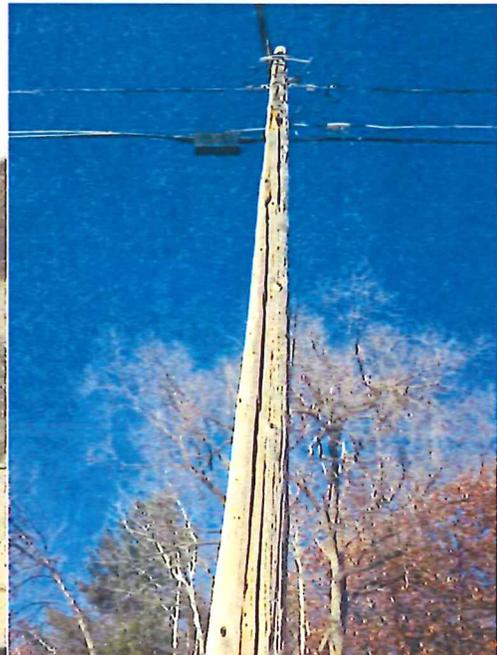
2. Wall 2 on south side of Riverside Dr N

- a. Numerous signs of deterioration
 - i. 3 degrees of lean downward
 - ii. Crumbling (scaling), wash-through, open joints, and deterioration of blocks at multiple levels. Most capstones are fully deteriorated.
 - iii. Utility pole is deteriorated and has inadequate line clearance
 - iv. There is only one drain for this wall which has no guarding for rodent intrusion

Collapse may take down power pole – property damage, electrical outage, and the potential to cause injury/death

Undermines and may cause collapse of Riverside Drive

Repairs to Wall #2 will require major excavation to correct lack of drainage and build proper foundation. There is a power pole located inches from Wall 2 that is at the end of useful life and it is not tall enough for adequate road surface to line clearance. It needs to be relocated in order to correct that situation.

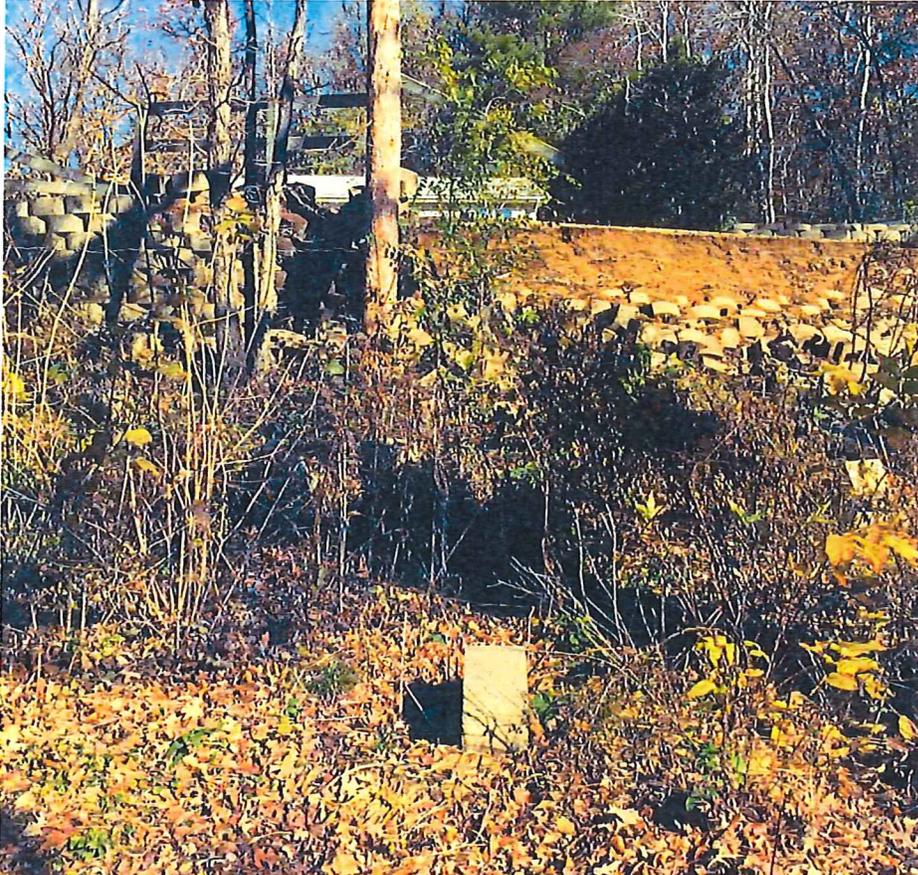
3. Wall 3 on south side of drive

- a. Displayed same symptoms described above before total collapse occurred in Nov. 2015

Remainder of wall is unstable and blocks could fall onto children playing on the debris.
