I am writing in regards to a series of 3 walls constructed by the village in 1990 as part of the "Riverside Drive Improvement Project".

All 3 walls in the vicinity of 1004 Riverside Dr N are in various stages of failure and pose safety risk to pedestrians, vehicles and property.

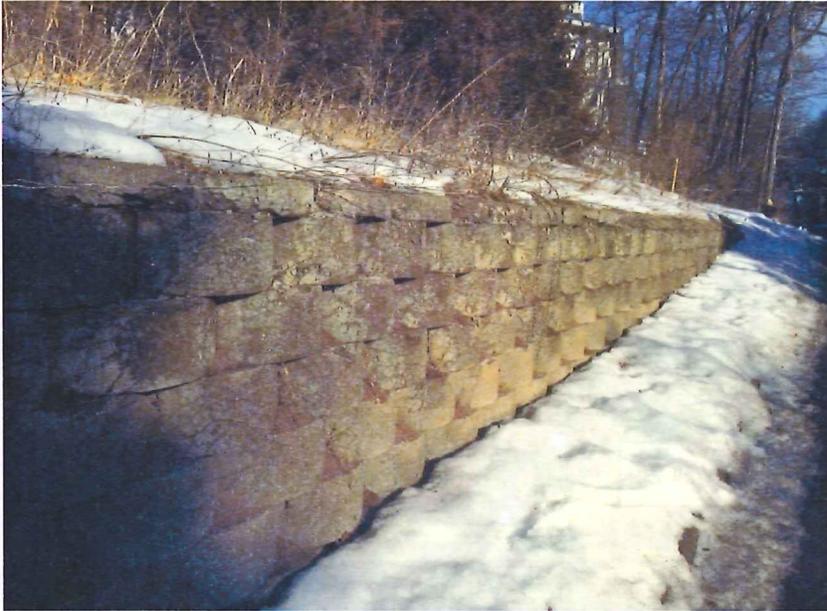
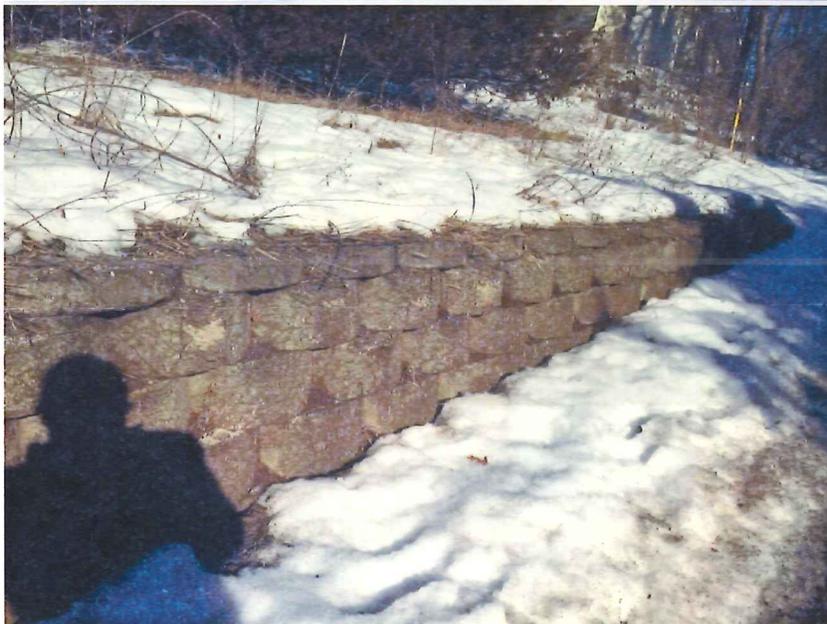
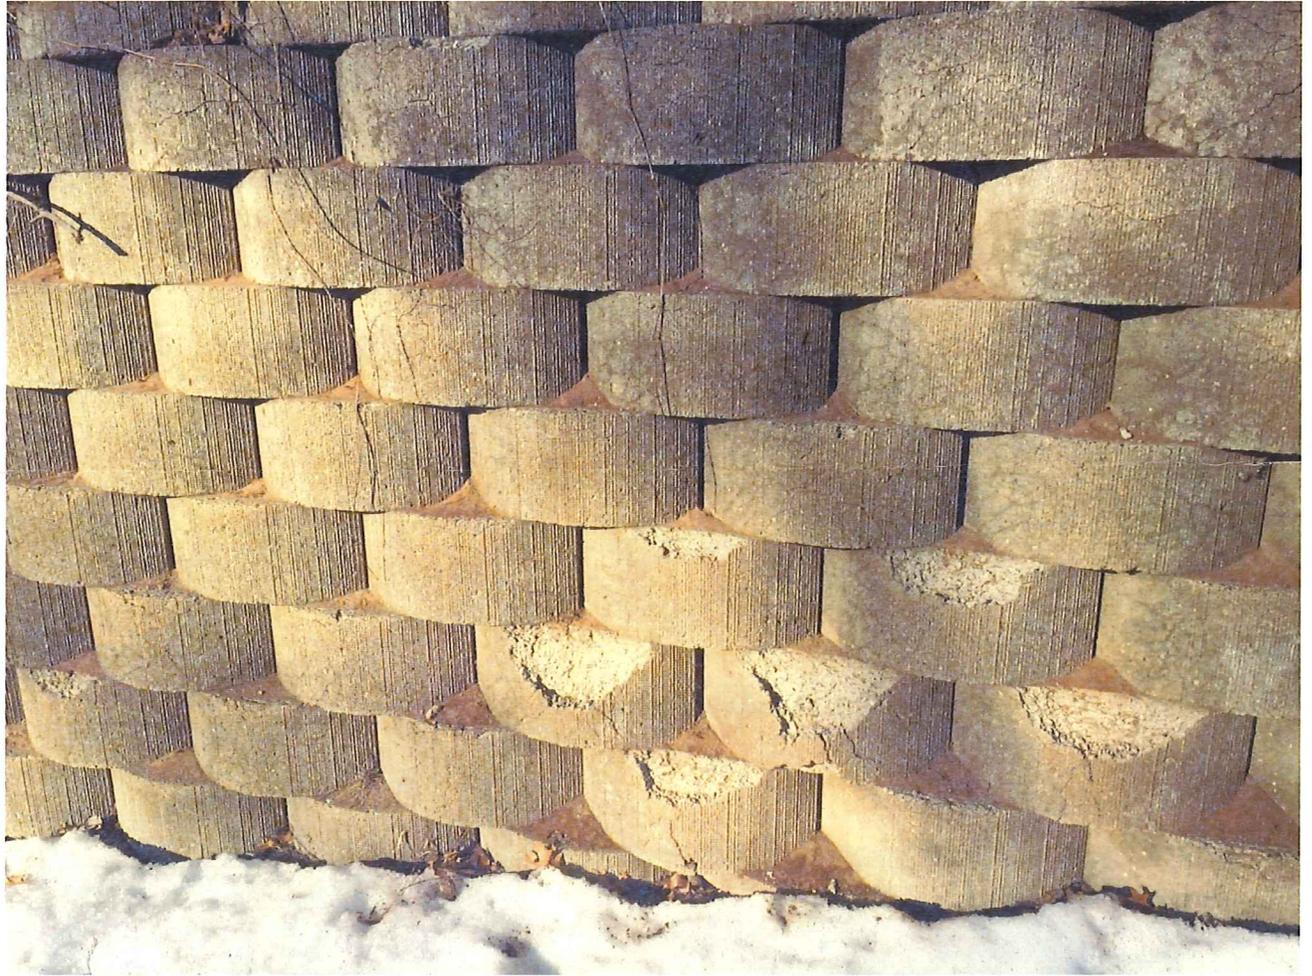
1. Wall 1 on north side of Riverside Dr N

a. Numerous signs of deterioration

i. 3 degrees of lean downward

ii. Crumbling (scaling), wash-through, open joints, and deterioration of blocks at multiple levels. Most capstones are fully deteriorated.

There is a high potential for collapse onto Riverside drive causing damage to cars and injury to pedestrians.

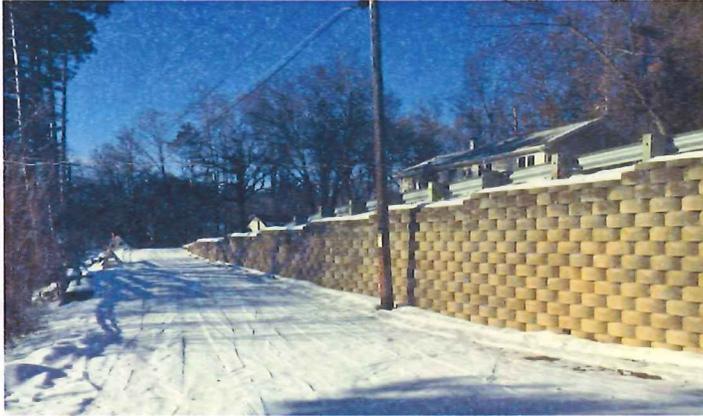
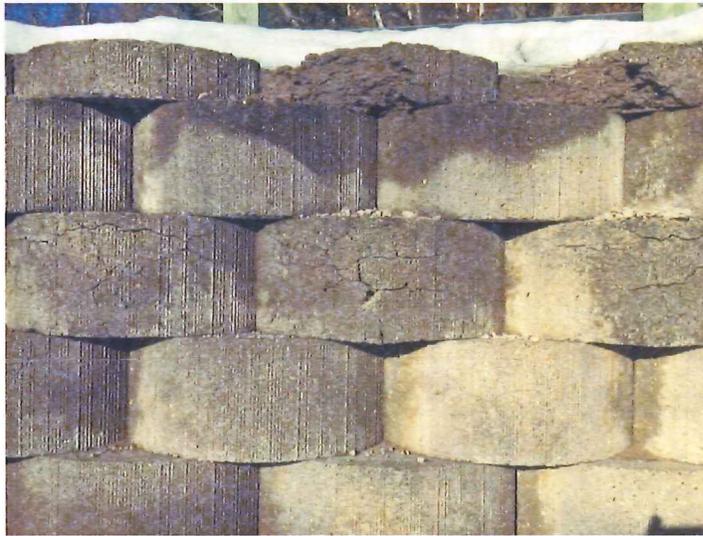
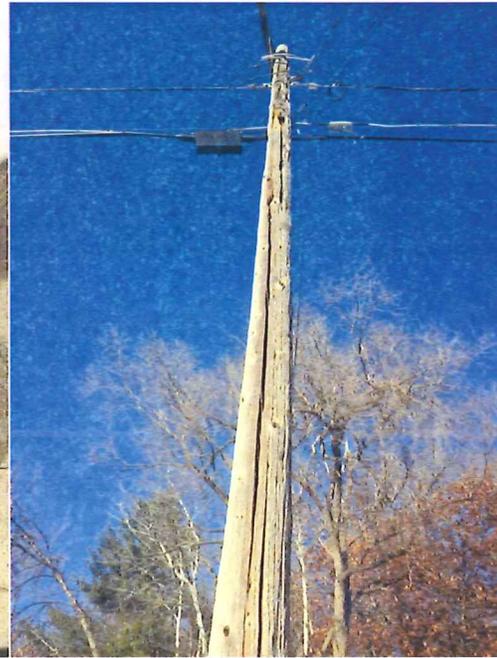
2. Wall 2 on south side of Riverside Dr N

- a. Numerous signs of deterioration
 - i. 3 degrees of lean downward
 - ii. Crumbling (scaling), wash-through, open joints, and deterioration of blocks at multiple levels. Most capstones are fully deteriorated.
 - iii. Utility pole is deteriorated and has inadequate line clearance
 - iv. There is only one drain for this wall which has no guarding for rodent intrusion

Collapse may take down power pole – property damage, electrical outage, and the potential to cause injury/death

Undermines and may cause collapse of Riverside Drive

Repairs to Wall #2 will require major excavation to correct lack of drainage and build proper foundation. There is a power pole located inches from Wall 2 that is at the end of useful life and it is not tall enough for adequate road surface to line clearance. It needs to be relocated in order to correct that situation.

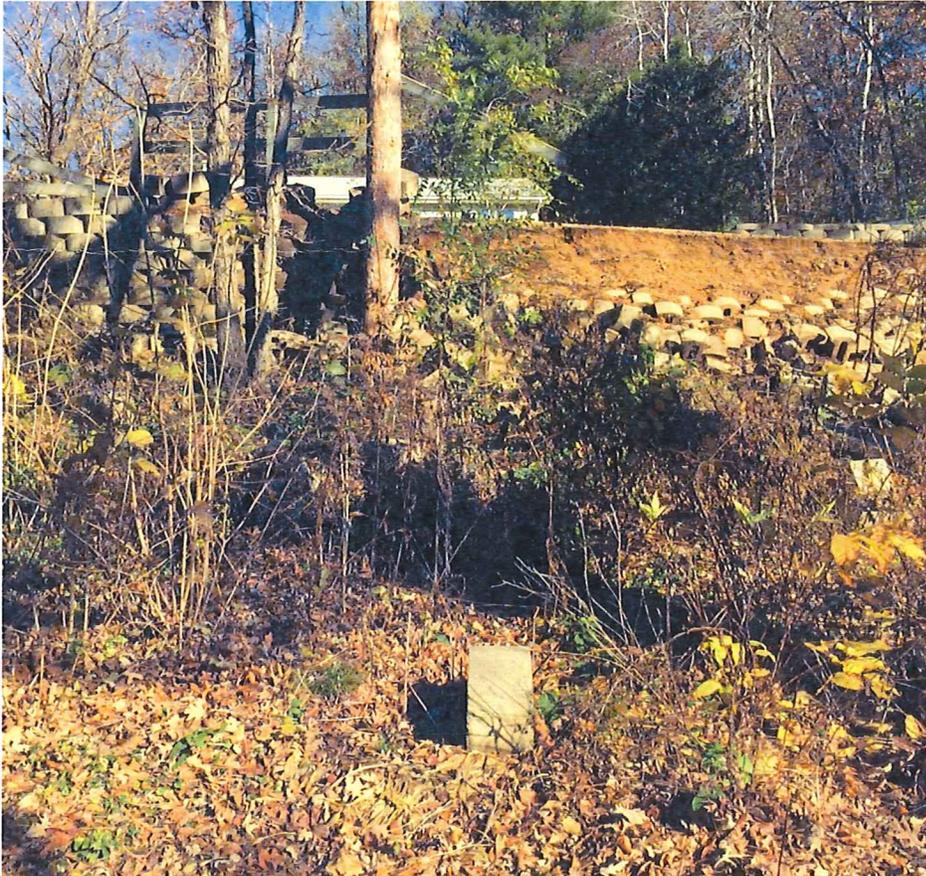
3. Wall 3 on south side of drive

- a. Displayed same symptoms described above before total collapse occurred in Nov. 2015

Remainder of wall is unstable and blocks could fall onto children playing on the debris.

All 3 walls were built to replace existing walls as a single Public Works project and need to be replaced as single engineered project. Wall 3 cannot be repaired, as an independent project, because it will require re-grading of the driveway which will potentially undermine Wall 2. Additionally it will need to be excavated in the near future for the replacement of Wall 2.
