ISSUE STATEMENT

North Hudson Public Works Committee

Watermain connection at 719 Sixth St. N.

VILLAGE OF NORTH HUDSON
S.T.H. 35 WATERMAIN CONNECTIONS

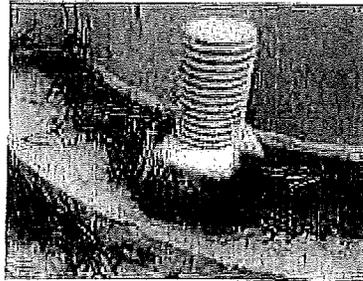
7. **Significant Deficiency:** several foundation bolts on the Lemon Street reservoir's legs are severely corroded and need to be replaced. This needs to be resolved by December 31, 2015. The welds on some of the support ties show severe corrosion as well. (ch. NR 810.14 Wis. Adm. Code)
